Sitting Shear

Inspection of shaft shoulder and bearings of slitting shear

Inspection of Slitting Shear

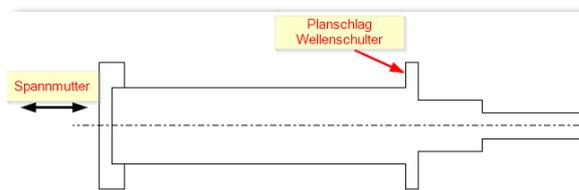
- > Measured axial run-out at shoulder of **upper** cutter shaft 0,002mm = **OK**
- > Measured axial run-out at shoulder of **lower** cutter shaft 0,001mm = **OK**

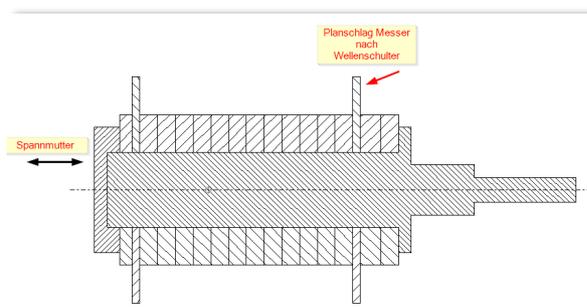
- > Axial play of **upper** cutter shaft bearing 0,001mm = **OK**
- > Axial play of **lower** cutter shaft bearing 0,002mm = **OK**
- > Axial play of **upper** eccentric bushing 0,005 mm = **OK**
- > Axial play of **lower** eccentric bushing 0,002 mm = **OK**

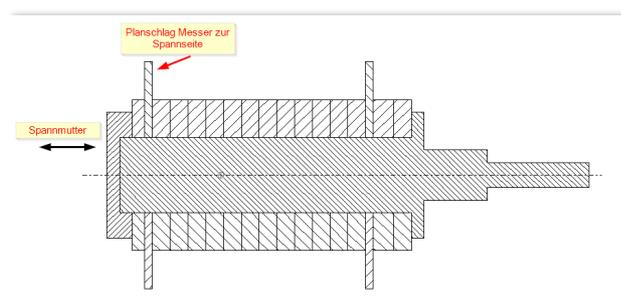
- > Measured axial run-out **upper** cutter shaft, first knife towards drive side 0,01 mm
- > Measured axial run-out **lower** cutter shaft, first knife towards drive side 0,01 mm

- > Measured axial run **upper** cutter shaft, first knife towards operator side 0,03mm
- > Measured axial run **lower** cutter shaft, first knife towards operator side 0,05mm

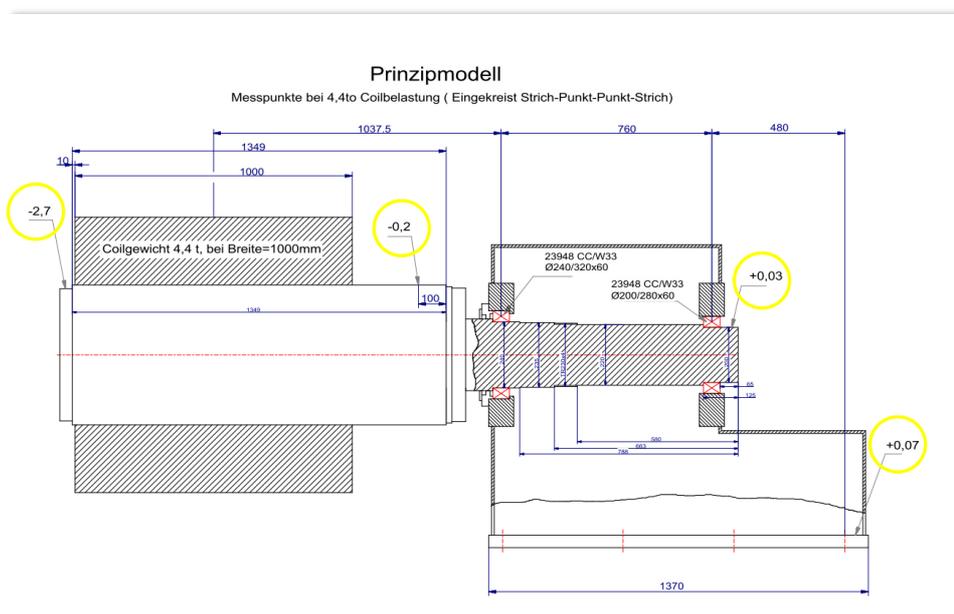
Inspection of recoiler

- > Measured movement on recoiler in case of 4.4 to coil load – see sketch above, measuring points are marked yellow.
- > Measuring procedure during measuring: Coil has been loaded via hall crane and sling.

- > Via crane stroke the 4.4 to coil has been lowered (charged with load) and lifted (load released) in alternation. Simultaneously the load was measured at 4 different positions as marked and measured by a dial gauge.

- > The results showed an unusual not admissible deflection of the recoiler shaft so it can be assumed that deflection does not come from the shaft but from the main bearing itself.

- o As per calculation the deflection at the front edge of the recoiler shaft with loaded coil of 4,4to should be **0,7 mm**, however **2,7mm** were measured.

- o The movement of the shaft in its rear bearing area shows 0,03 mm which is in the normal range.
 - o There should not be a movement of 0,07 mm of the recoiler base frame when charging with load.

- o When checking the foundation bolts, it was found that they were not fastend tightly and could not be refixed perfectly. So fastening did not lead to an improvement of the situation.

- > Check foundation and fixation of anchoring bolts as well as grouting if necessary renew (foundation builder)
- > New bearing support (GEORG)

After execution of our proposal how to remedy the problems of the recoiler a movement of the slit coils should be possible again without any problem.

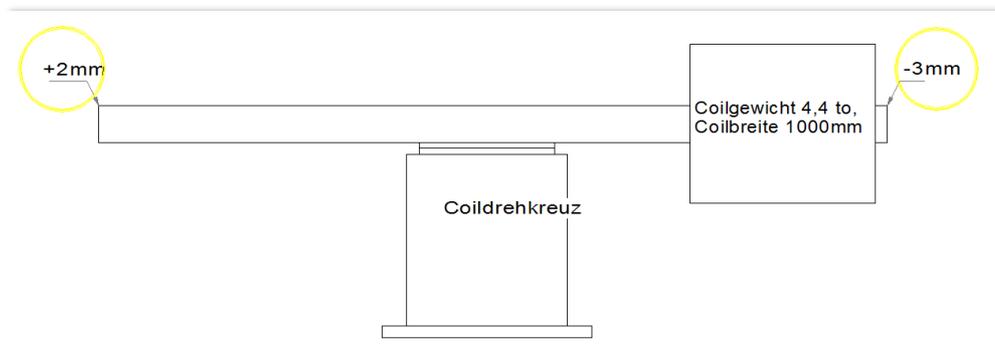
Turnstile check

- > Measured movement on coil turnstile with 4.4 to coil load as shown on the above sketch. Measuring points are marked in yellow.
- > Measuring procedure during measuring: Coil has been loaded via hall crane and sling.
- > Via crane stroke the 4.4to coil was placed onto the turnstile arm (charged with load) resp. lifted (load released) whilst simultaneously to the loading measurements were taken at the 2 indicated positions by dial gauge.
- > The measuring results showed that to a large extent the tilting was caused by a too large play of the swiveling bearing.

- > The situation should be kept in mind and observed, at present it is not a serious problem.
- > By replacing the swiveling bearing the tilting can be considerably reduced.
- > In addition, the guides of the locking mechanism are worn and should be replaced.

We further recommend to replace the swiveling gear of the turnstile and the cylinder guide of the locking mechanism. Hereby a tilting can be absorbed as far as possible and a secure locking in the 4 positions will be possible again.
